BUREAU OF SHIPS
TECHNICAL INSPECTION REPORT.

OPERATION CROSSROADS.
U.S.S. FALLON (APA 81).

TEST BAKER.

VOLUME 2 [U].

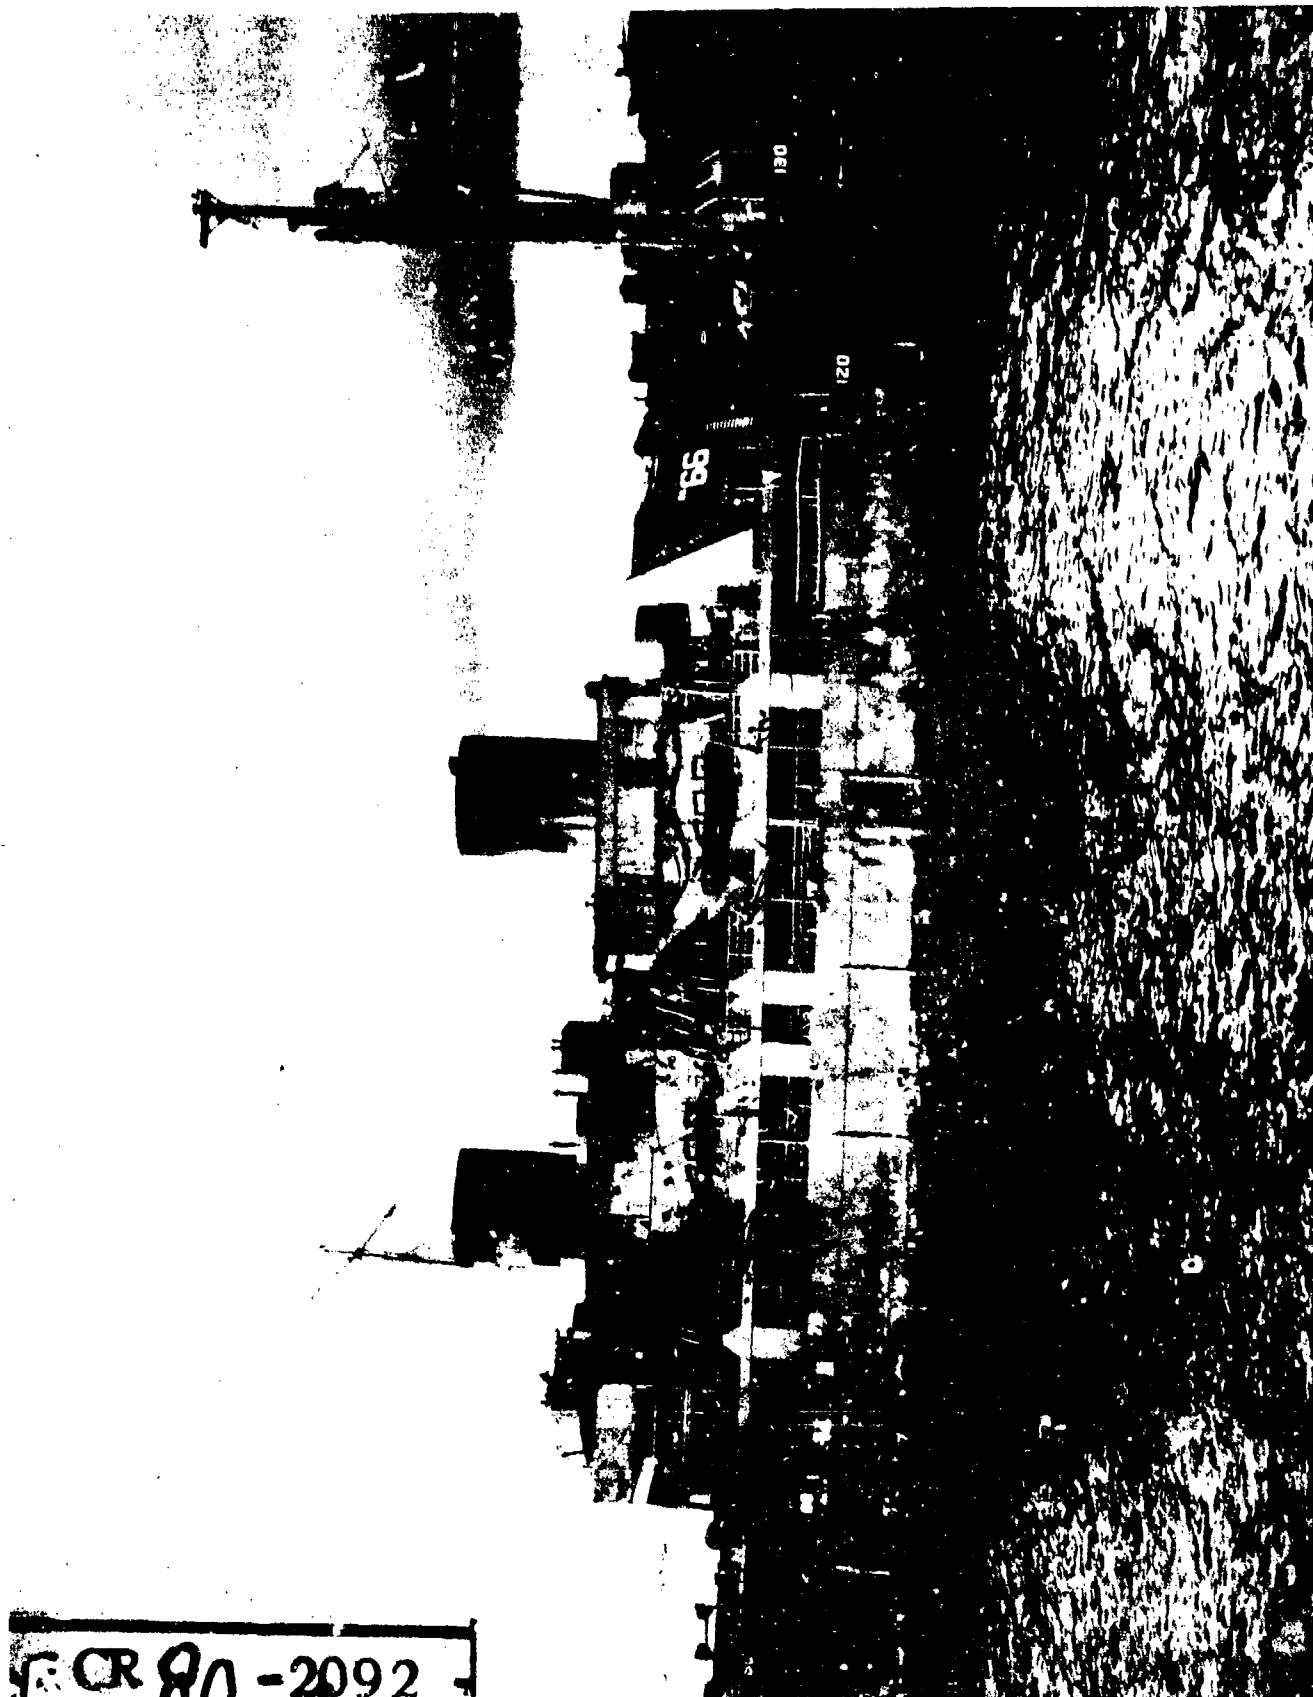
AB-CR-80-2092-1

AB-CR-80-2092-1. View of port side amidships, showing severe buckling of shell between frames 93 and 98 and damage to after stack.

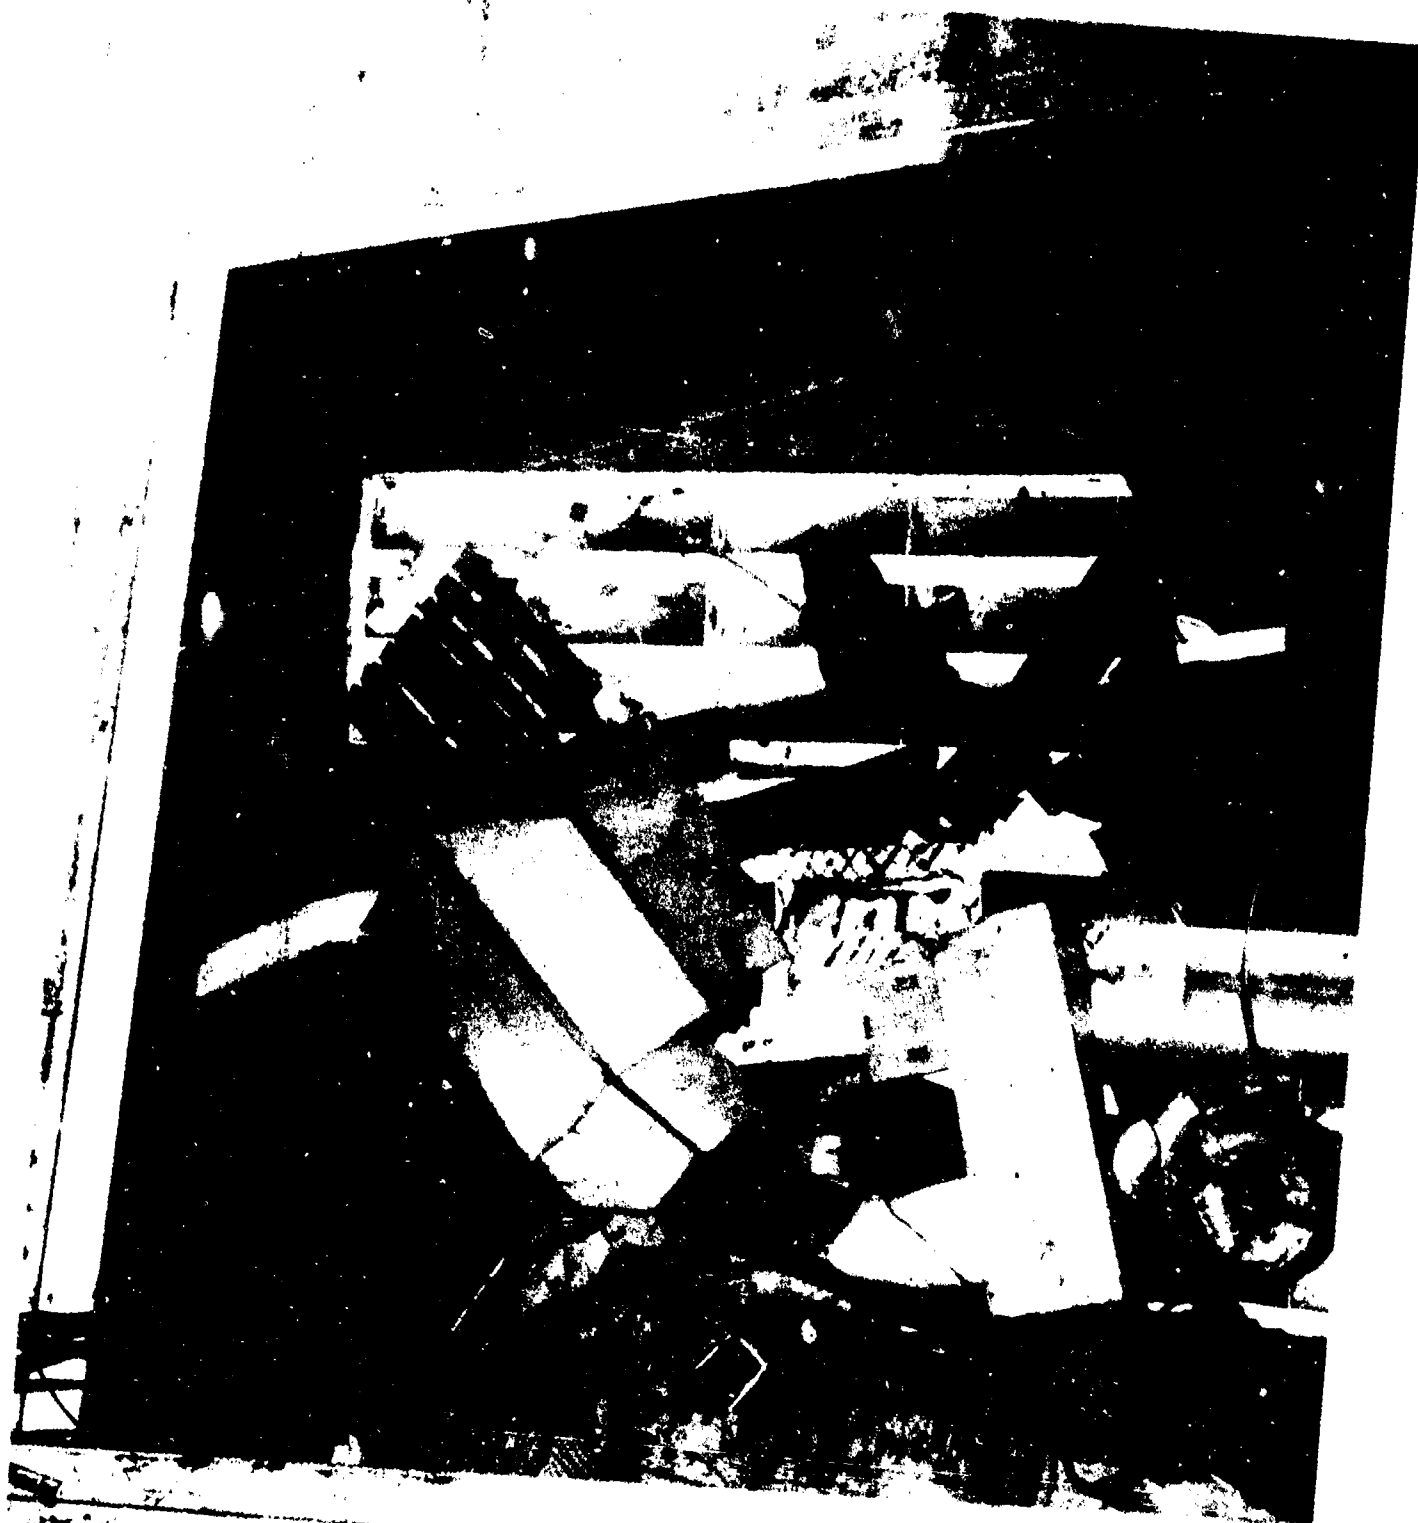
AB-CR-80-2197-2. View looking down into No. 1 cargo hold, from port to starboard, showing hatch covers dislodged from main deck and 1st platform levels. Note disarrangement of ballast in hold.

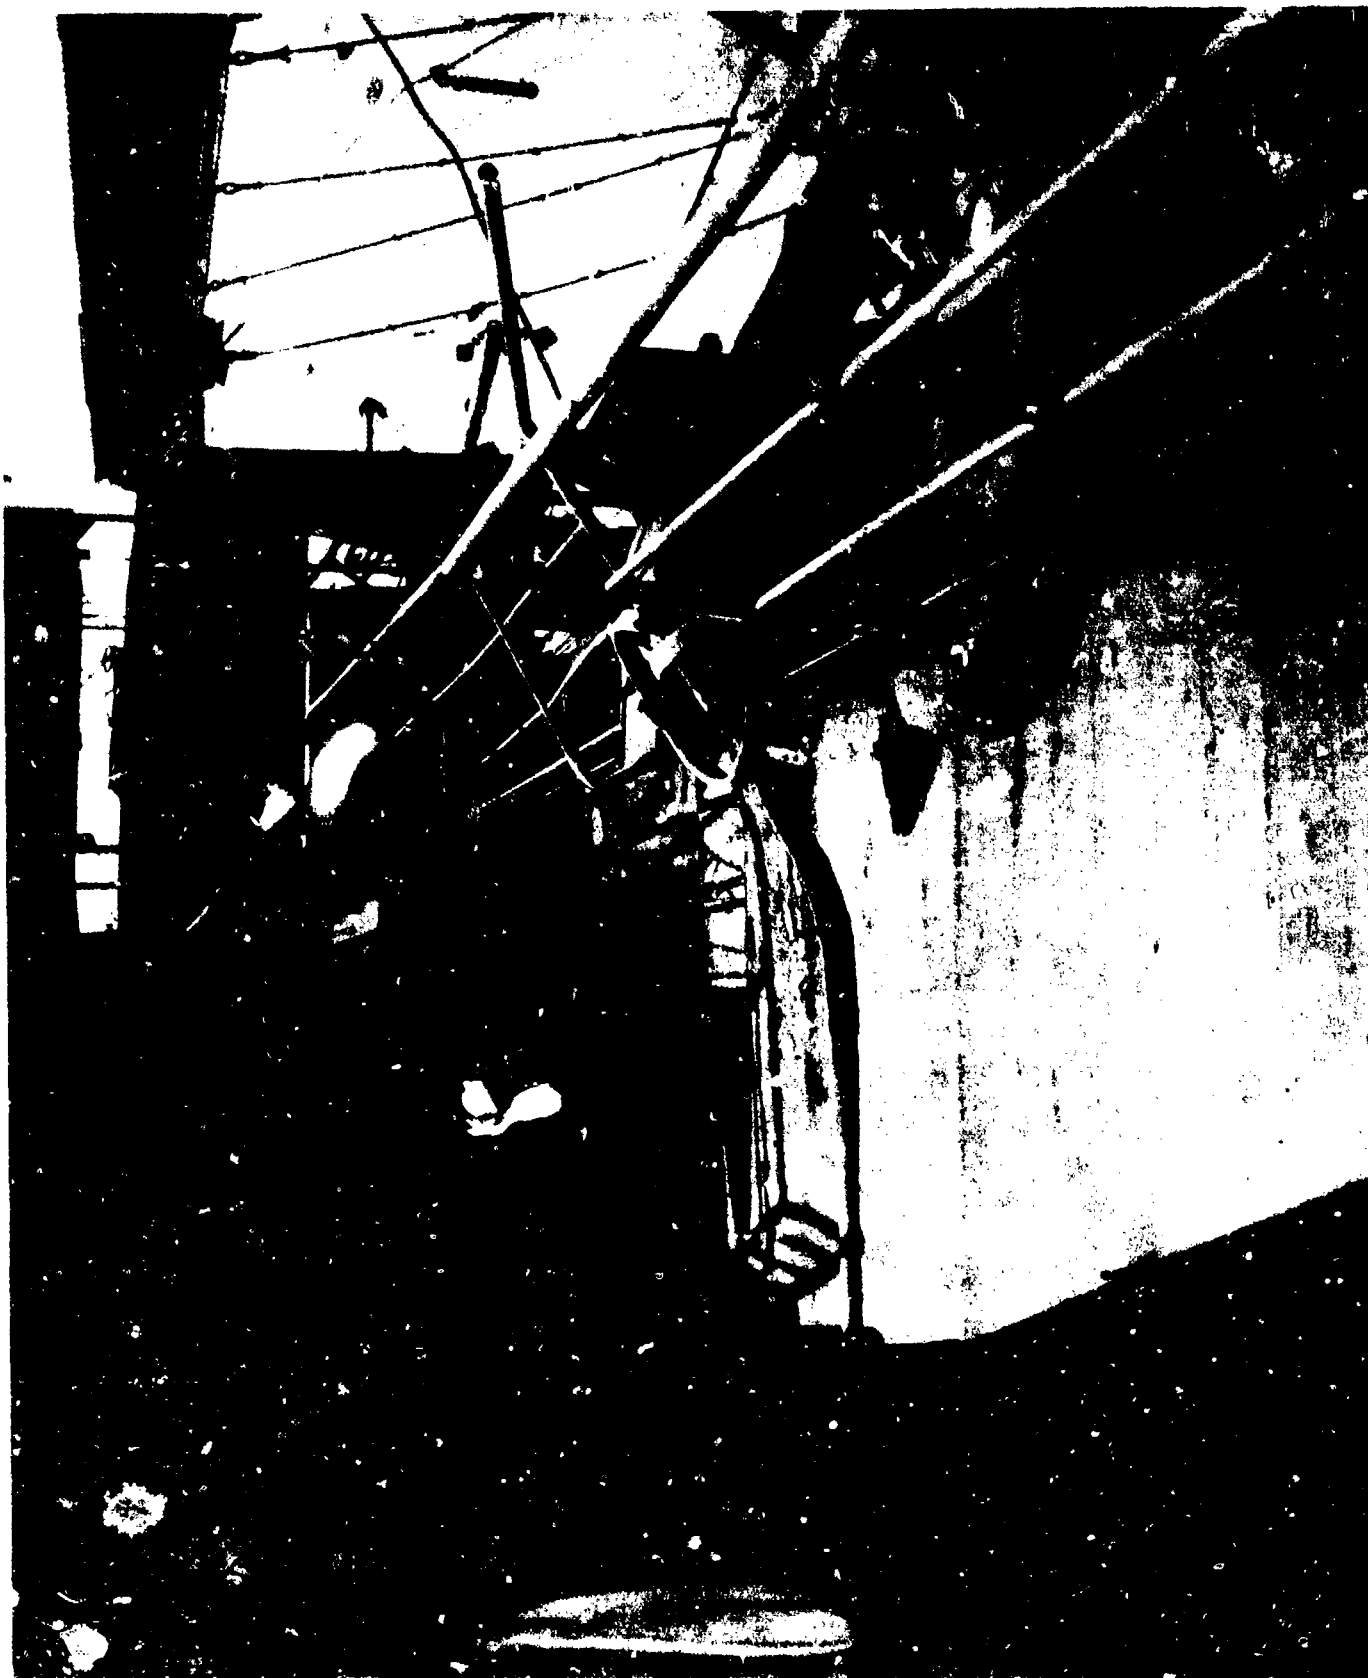
AB-CR-66-163-5. General view, looking forward along starboard side of navigation deck from about frame 83.

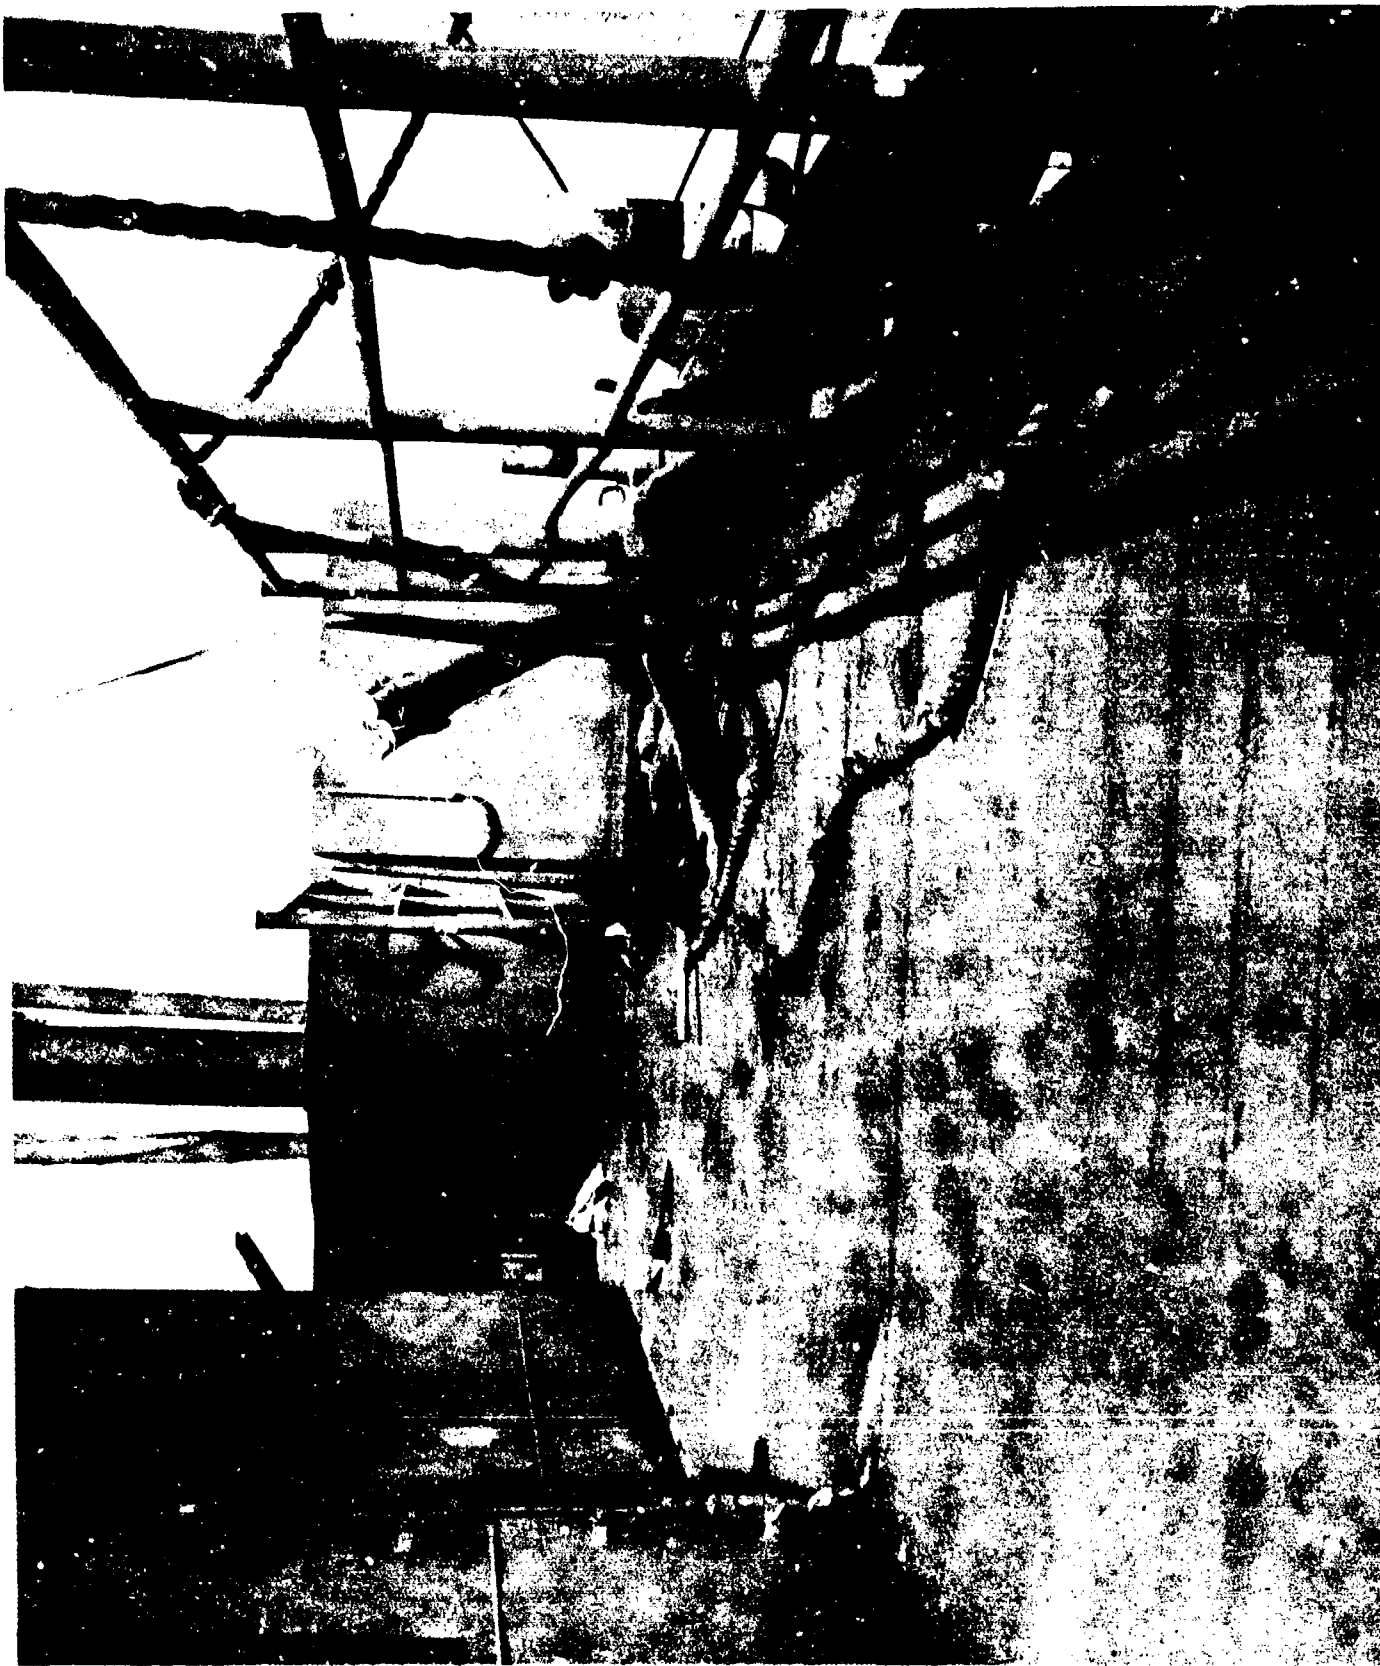
AB-CR-66-163-4. Ripples in Navigation deck, port side, looking aft from about frame 101.

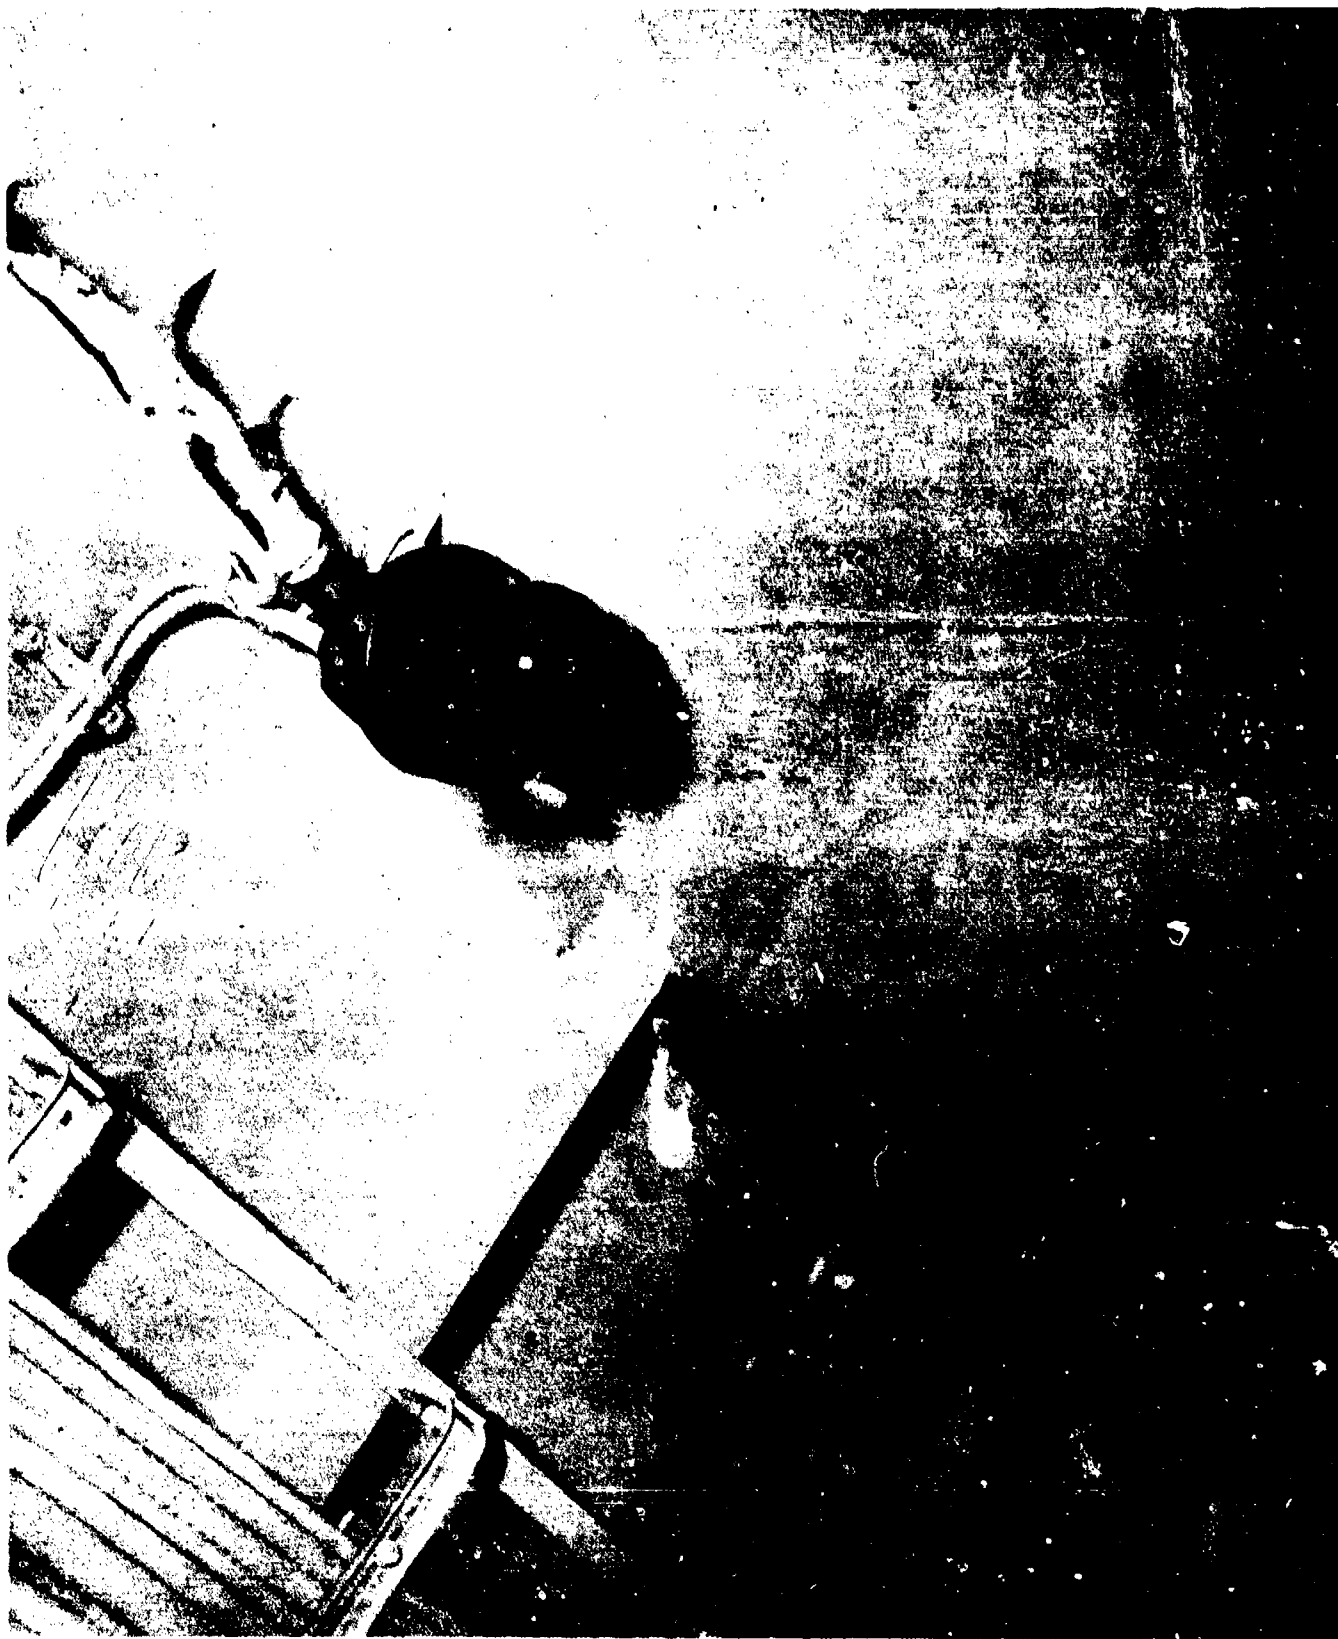
AB-CR-66-163-11. Superstructure deck, frame 88, looking aft along port longitudinal joiner bulkhead in passageway.

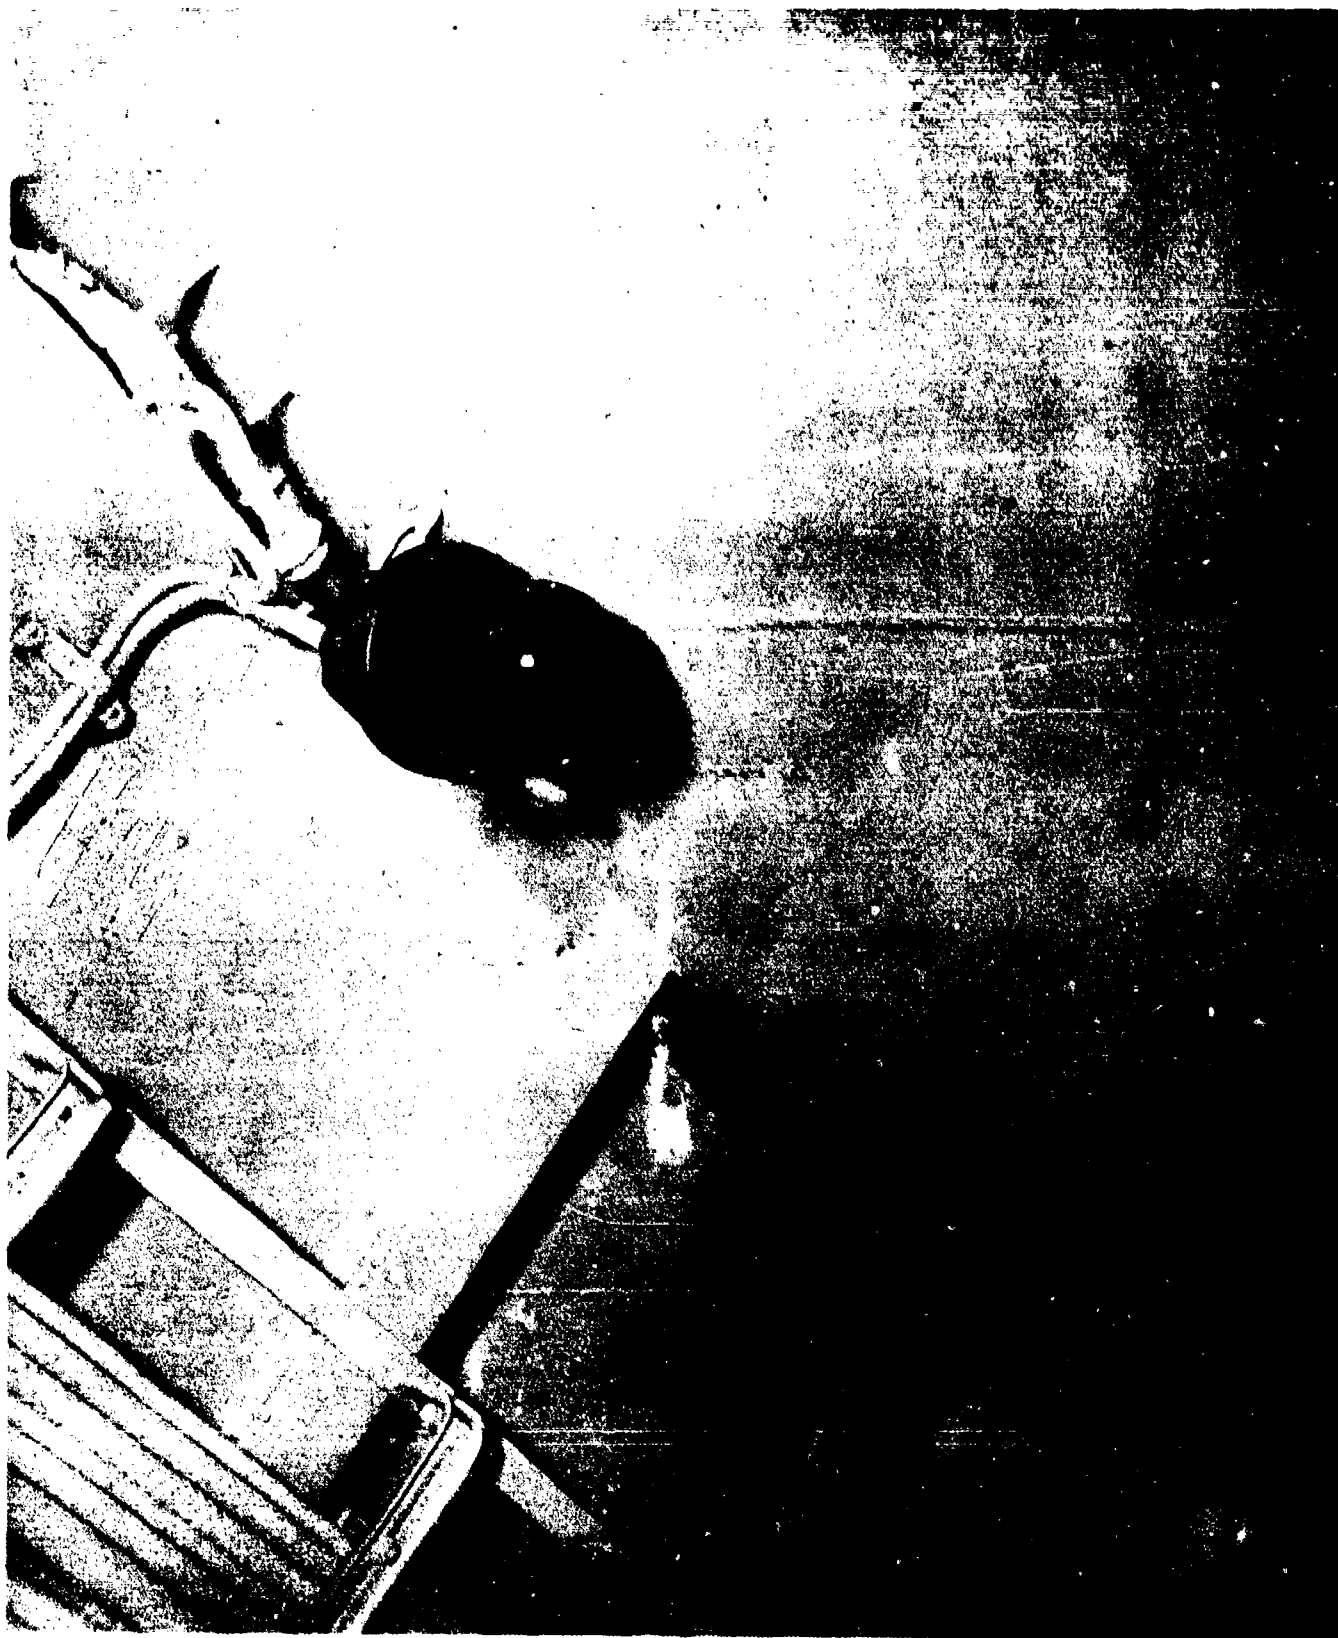
AB-CR-66-163-11. Superstructure deck, frame 88, looking aft along port longitudinal joiner bulkhead in passageway.

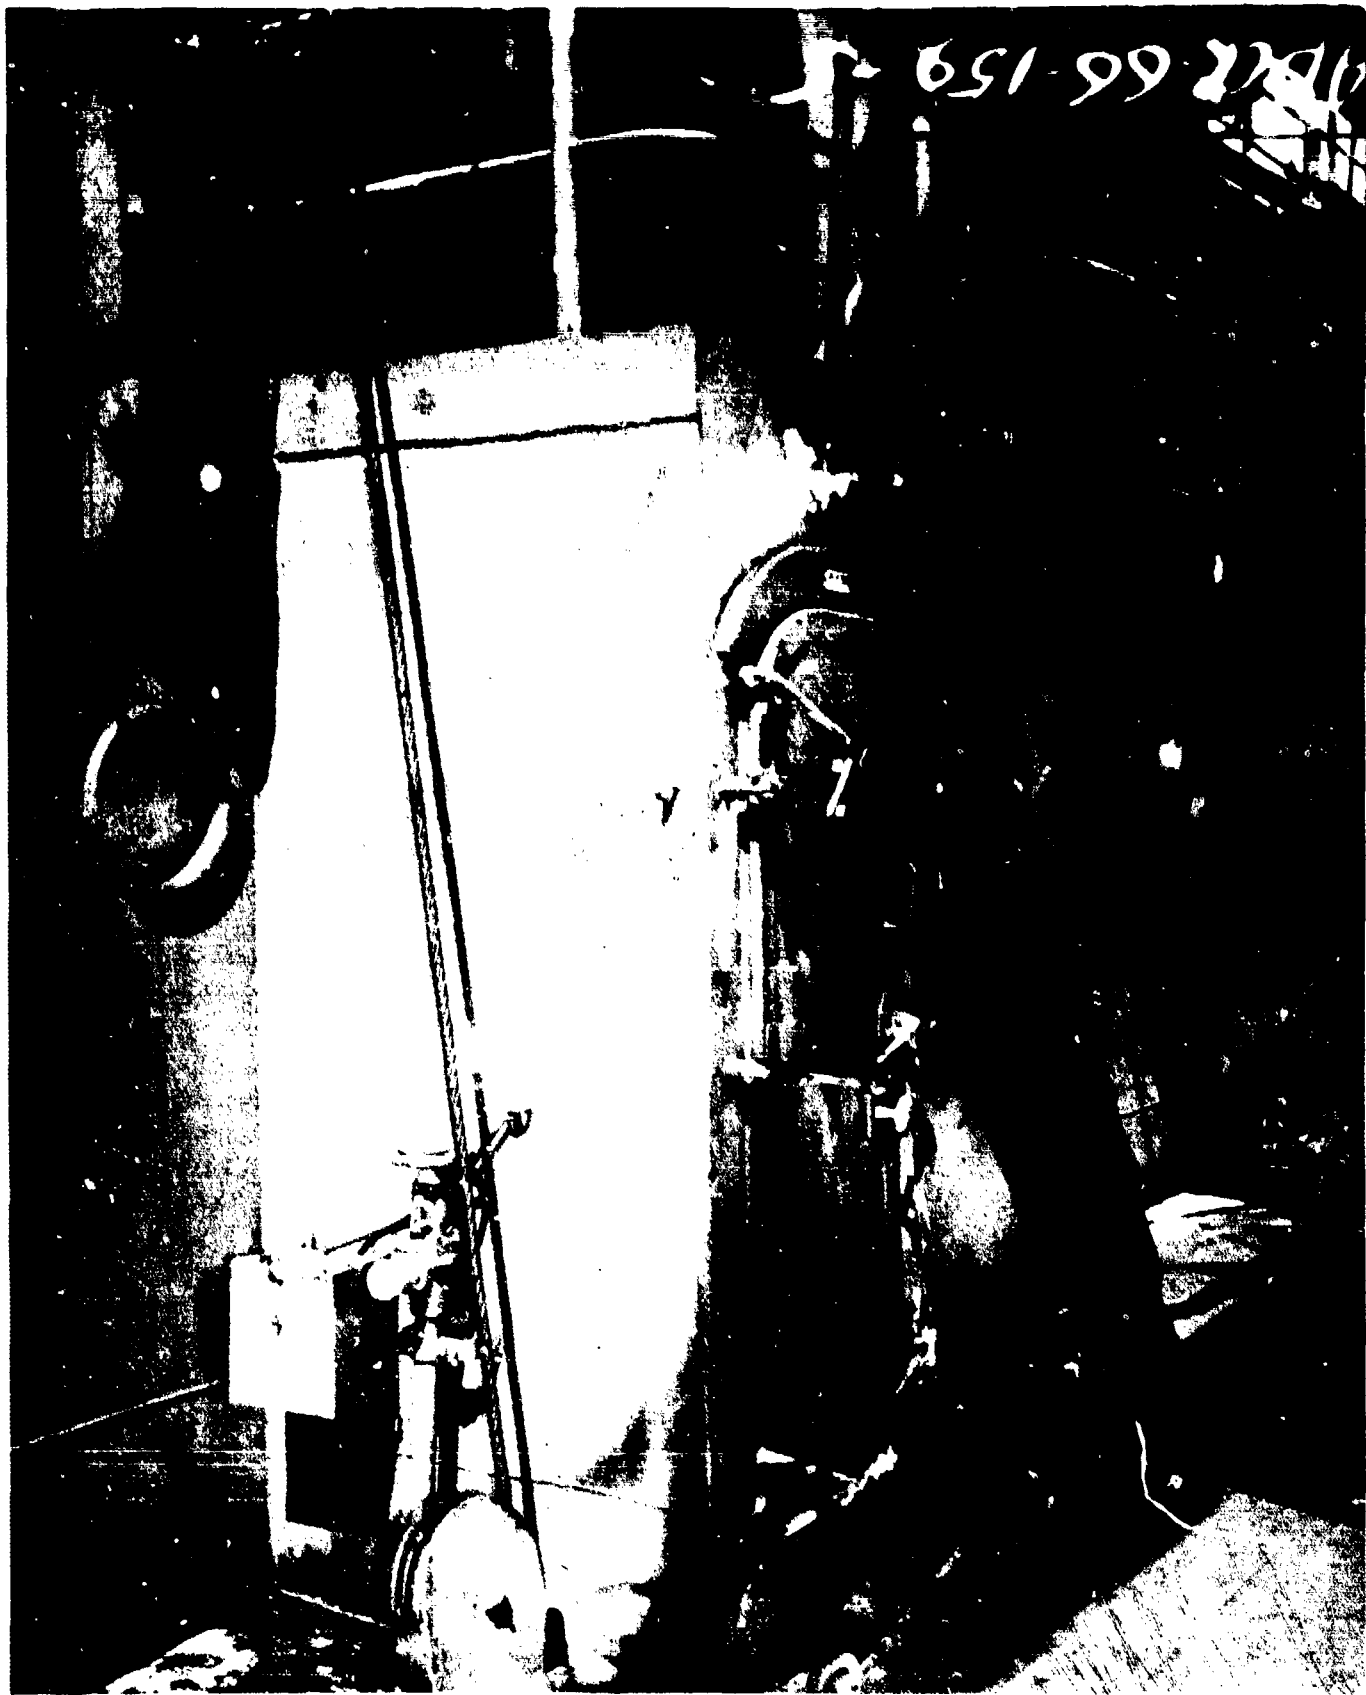
AB-CR-66-159-5. Dished companionway door and plating on upper deck, port side, frame 85, looking aft.

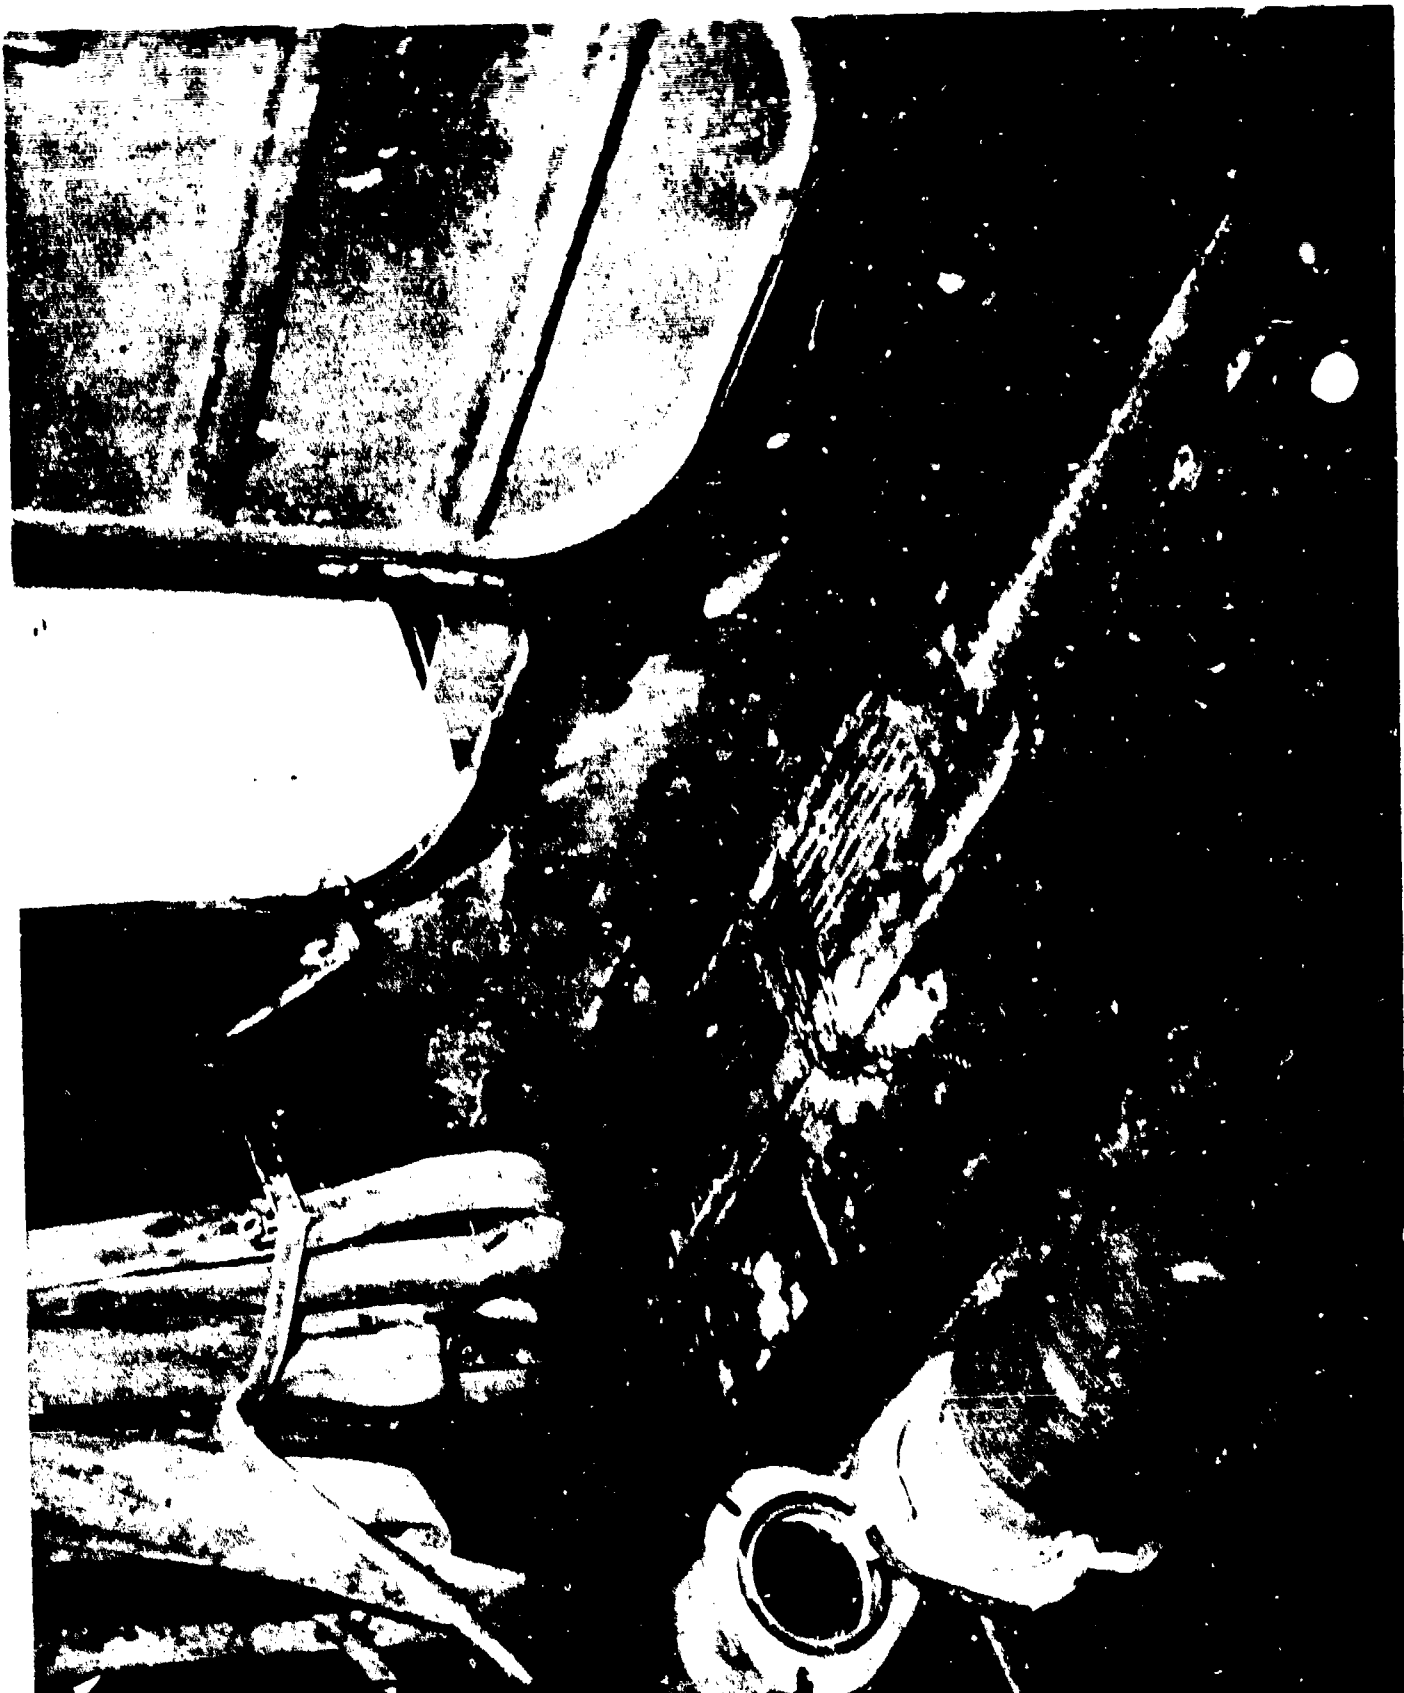
AB-CR-66-159-12. Starboard side of deck house, main deck, showing buckling in way of door at frames 67-68.

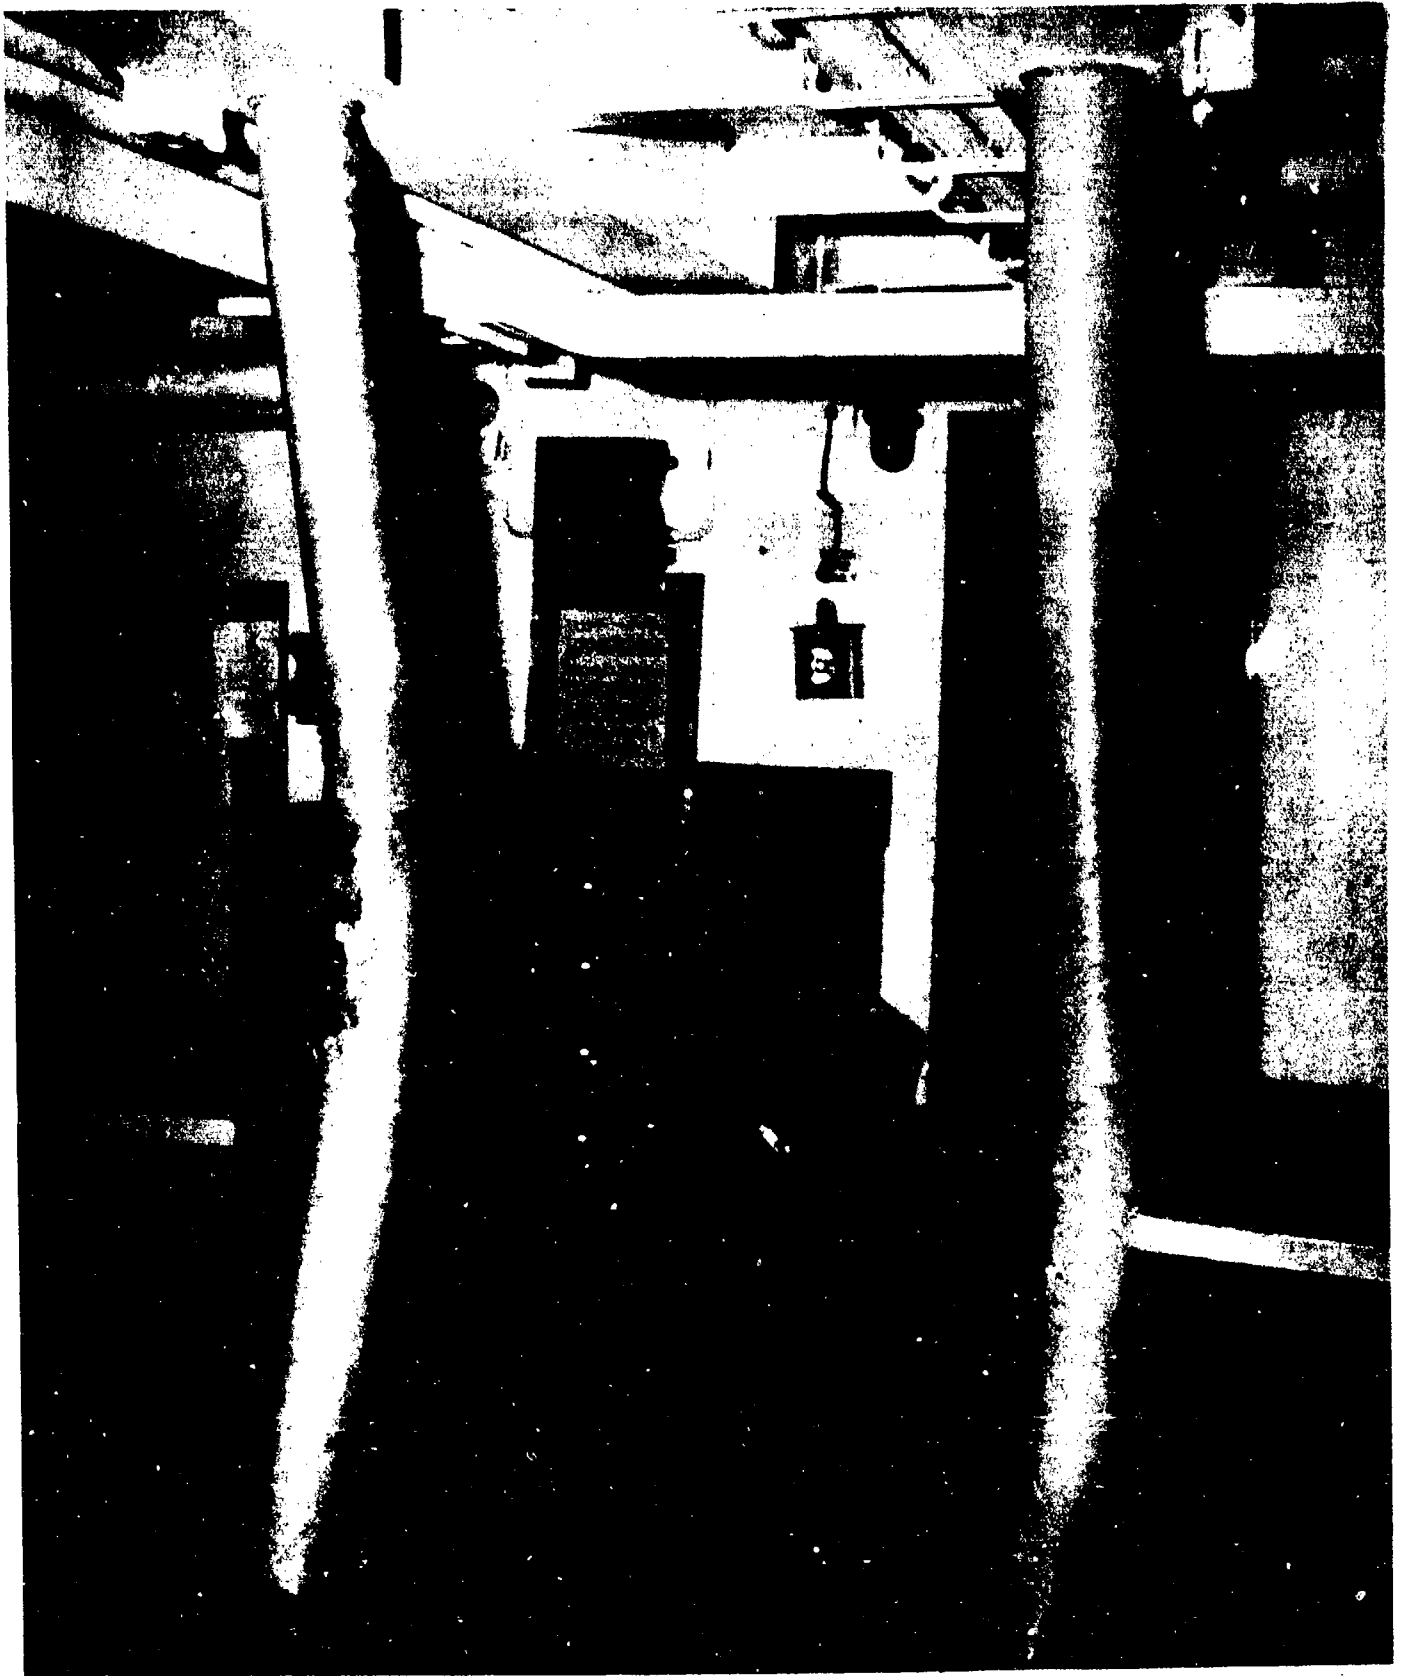
AB-CR-66-163-12. Buckling of stanchions on upper deck at frame 76, looking forward in wardroom. Note locker disarranged.

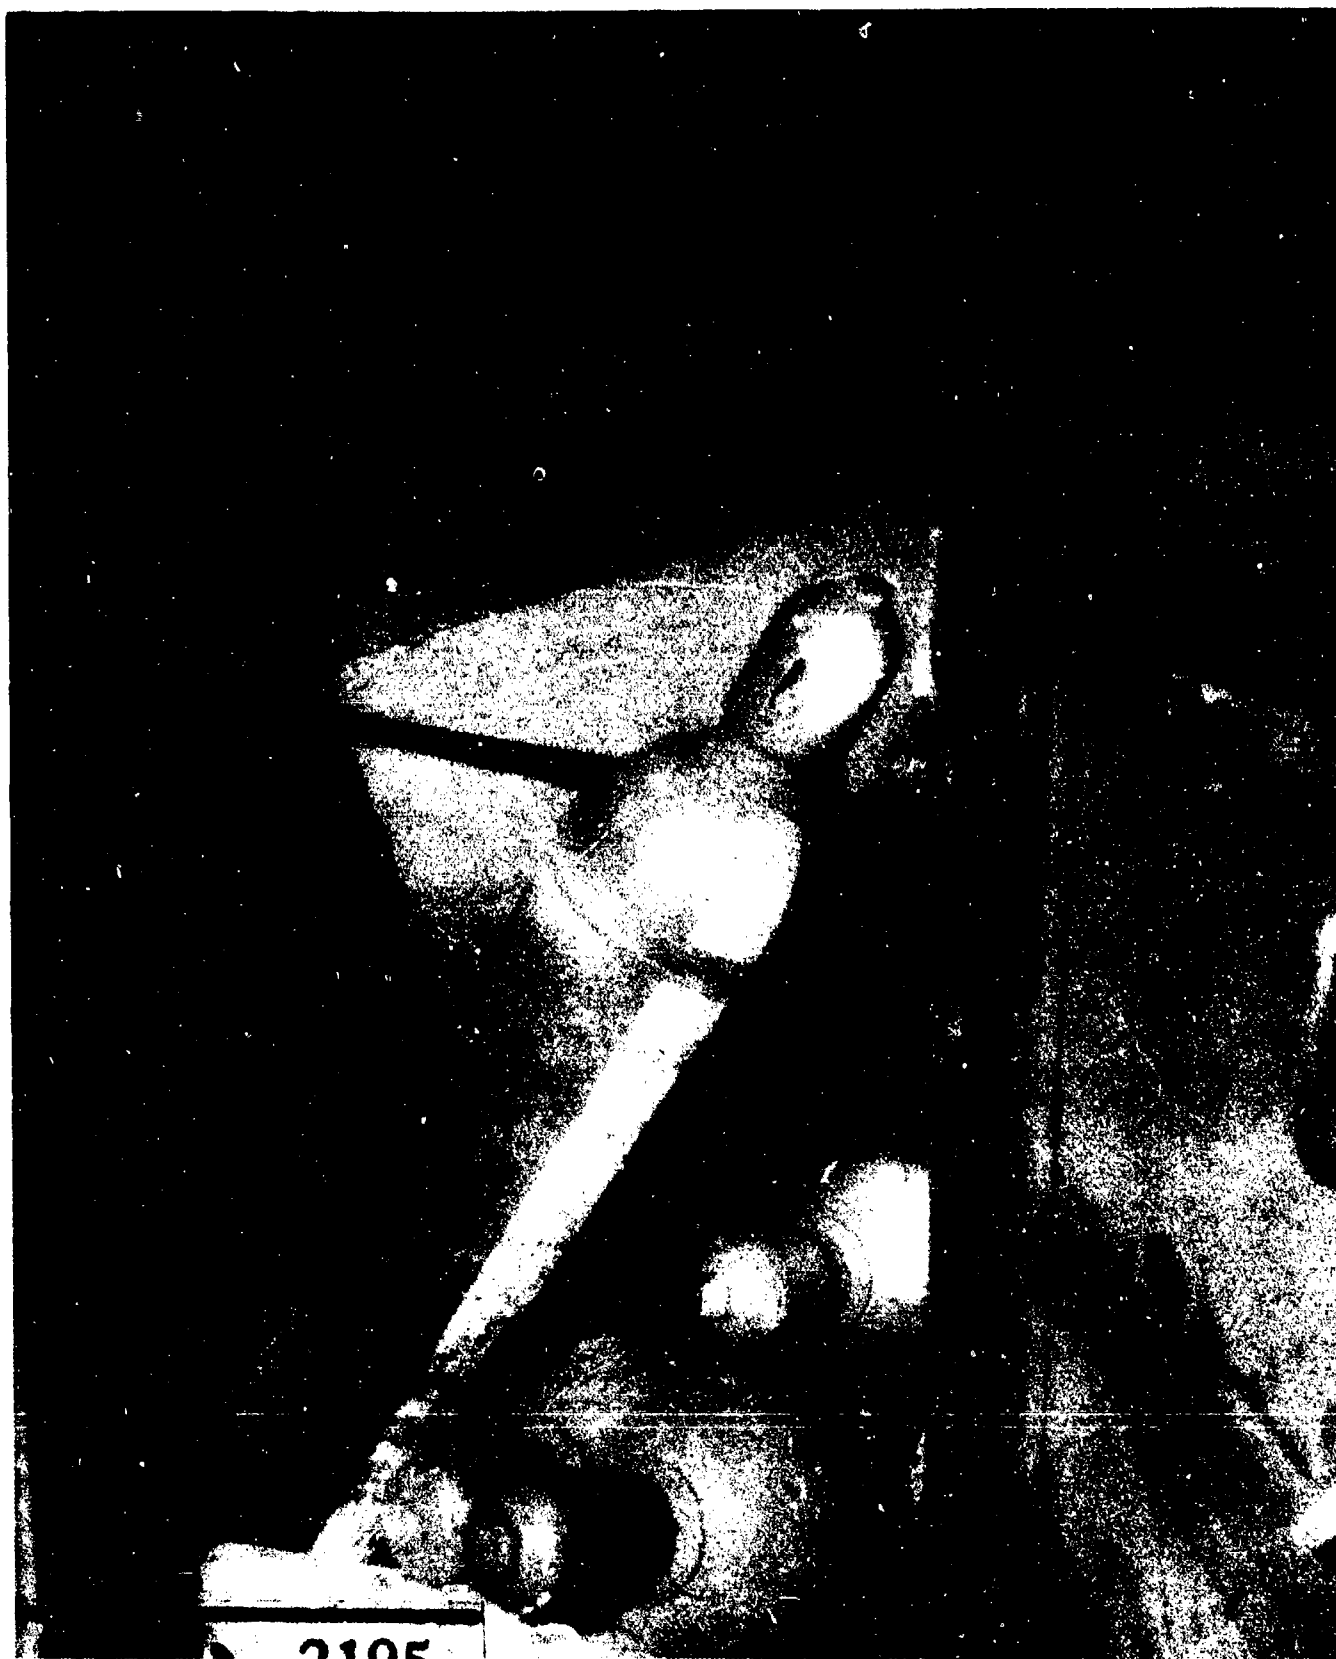
AB-CR-80-2195-12. Disarrangement of bottles and plywood stowage in starboard passage, upper deck, frames 135 to 138.
